PFP Demolition Briefing

May 2017

PFP: Last Stop of Plutonium Production at Hanford

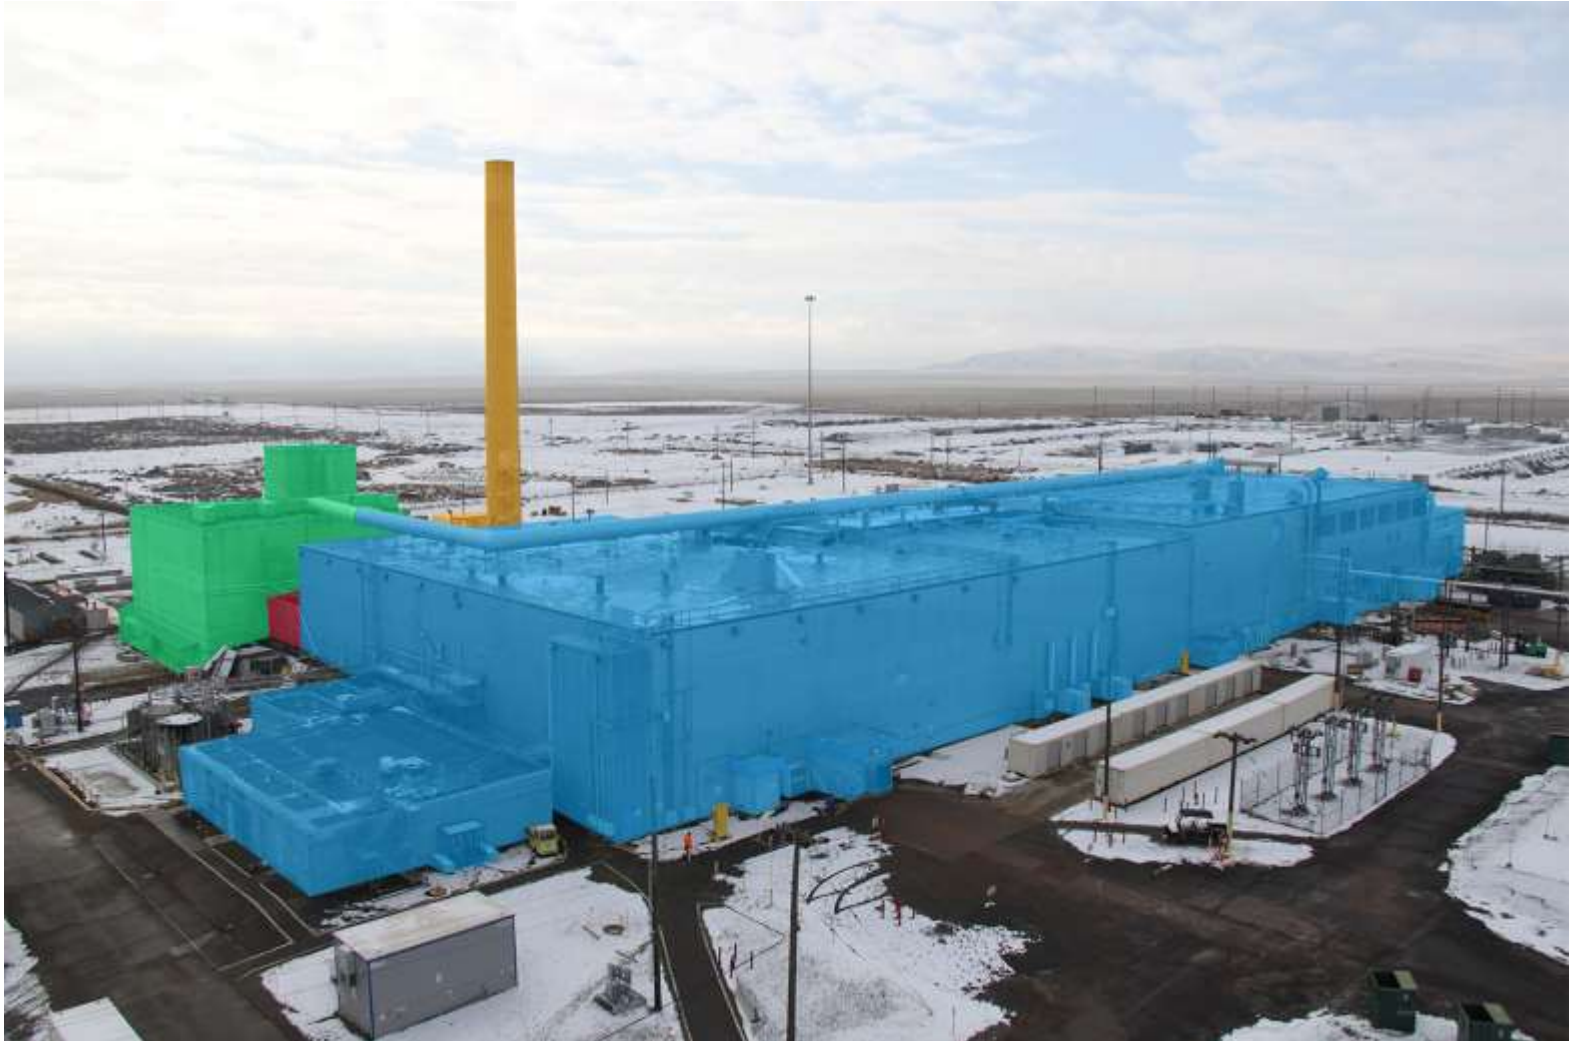
PFP: The Lay of the Land

236-Z
Plutonium
Reclamation
Facility (PRF)

242-Z
McCluskey
Room

234-5Z
Plutonium
Finishing Plant
(PFP)

291-Z
Fan House,
Stack

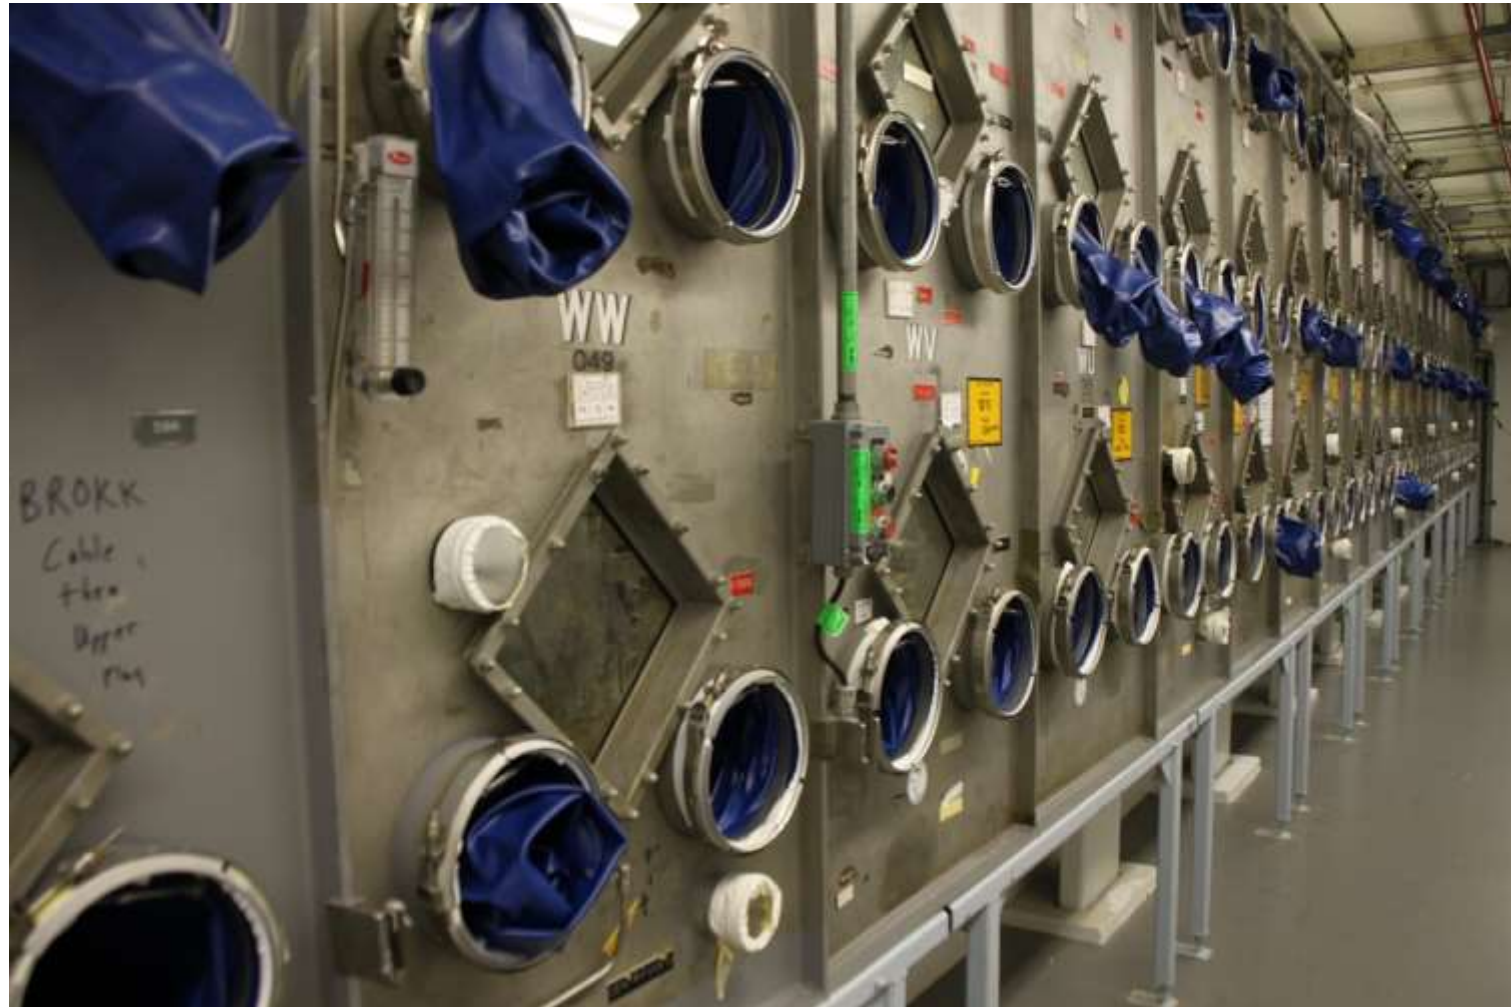
PRF Gallery Glove Boxes

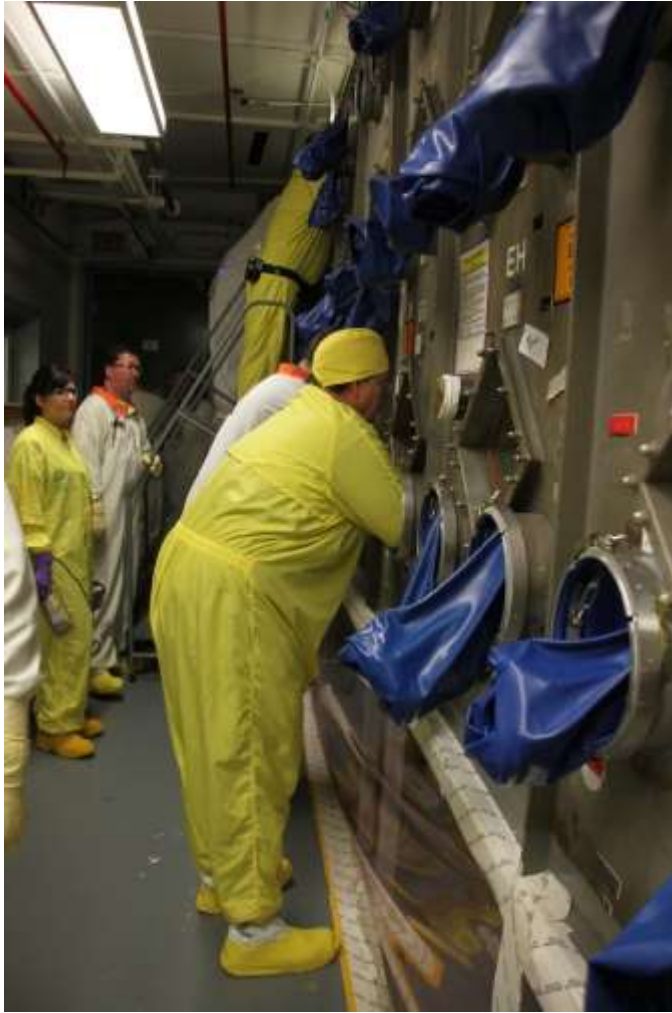
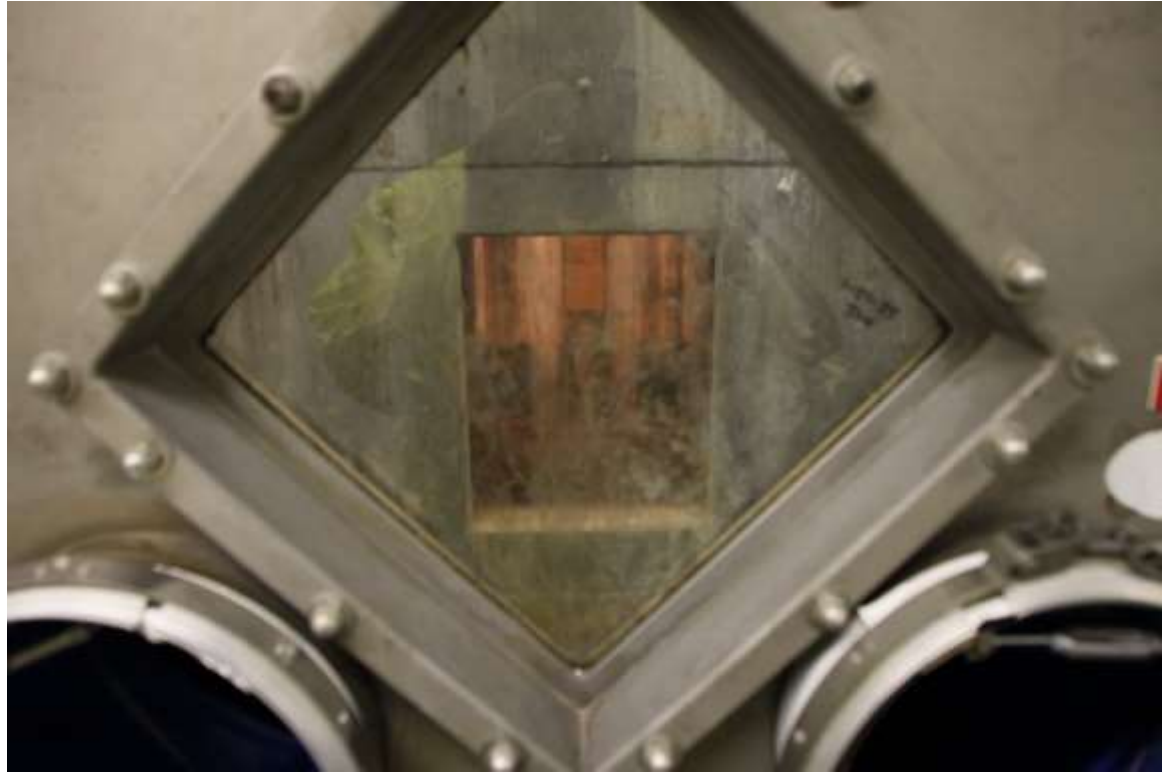
PRF Gallery Glove Boxes

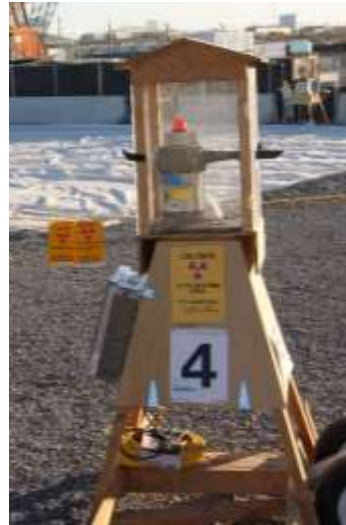
Air monitoring

- Real time radiological monitoring helps control process
- Ground maintenance, fixatives and fencing to avoid contamination spread
- Expeditious packaging and load out of contaminated debris
- Modeling dictates ready for demolition criteria
- Fixatives and fogging to control airborne hazards
- Water runoff management

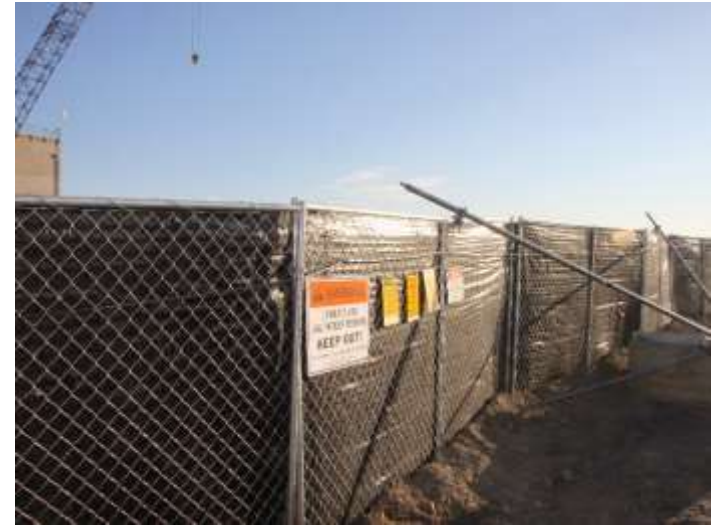
Demo fence/silt fencing

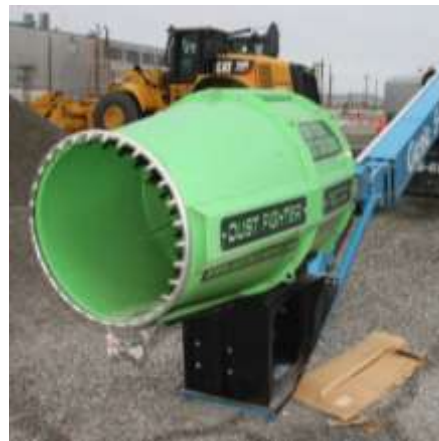
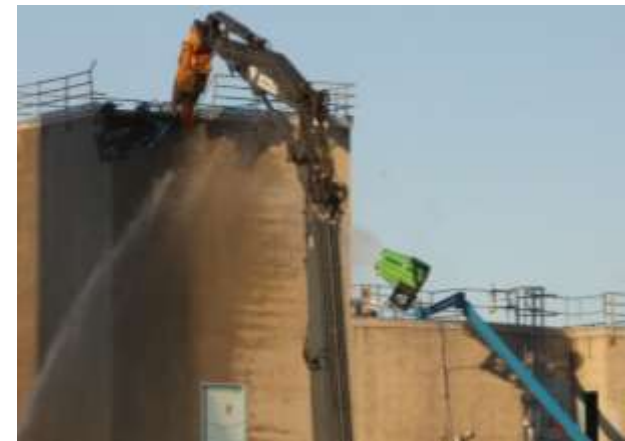
Precision fogger at PFP

- The highest contaminated items removed as a unit before, or prepared for removal during, demolition
- Residual surface contamination controlled via fixative and/or epoxy prior to demolition
- Extensive fogging, water suppression and fixative used
- Boundaries modeled by Pacific Northwest National Lab based on radiological conditions and demolition methods

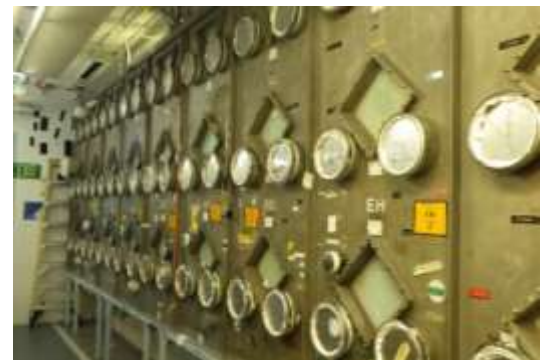
Painted out gallery glove box

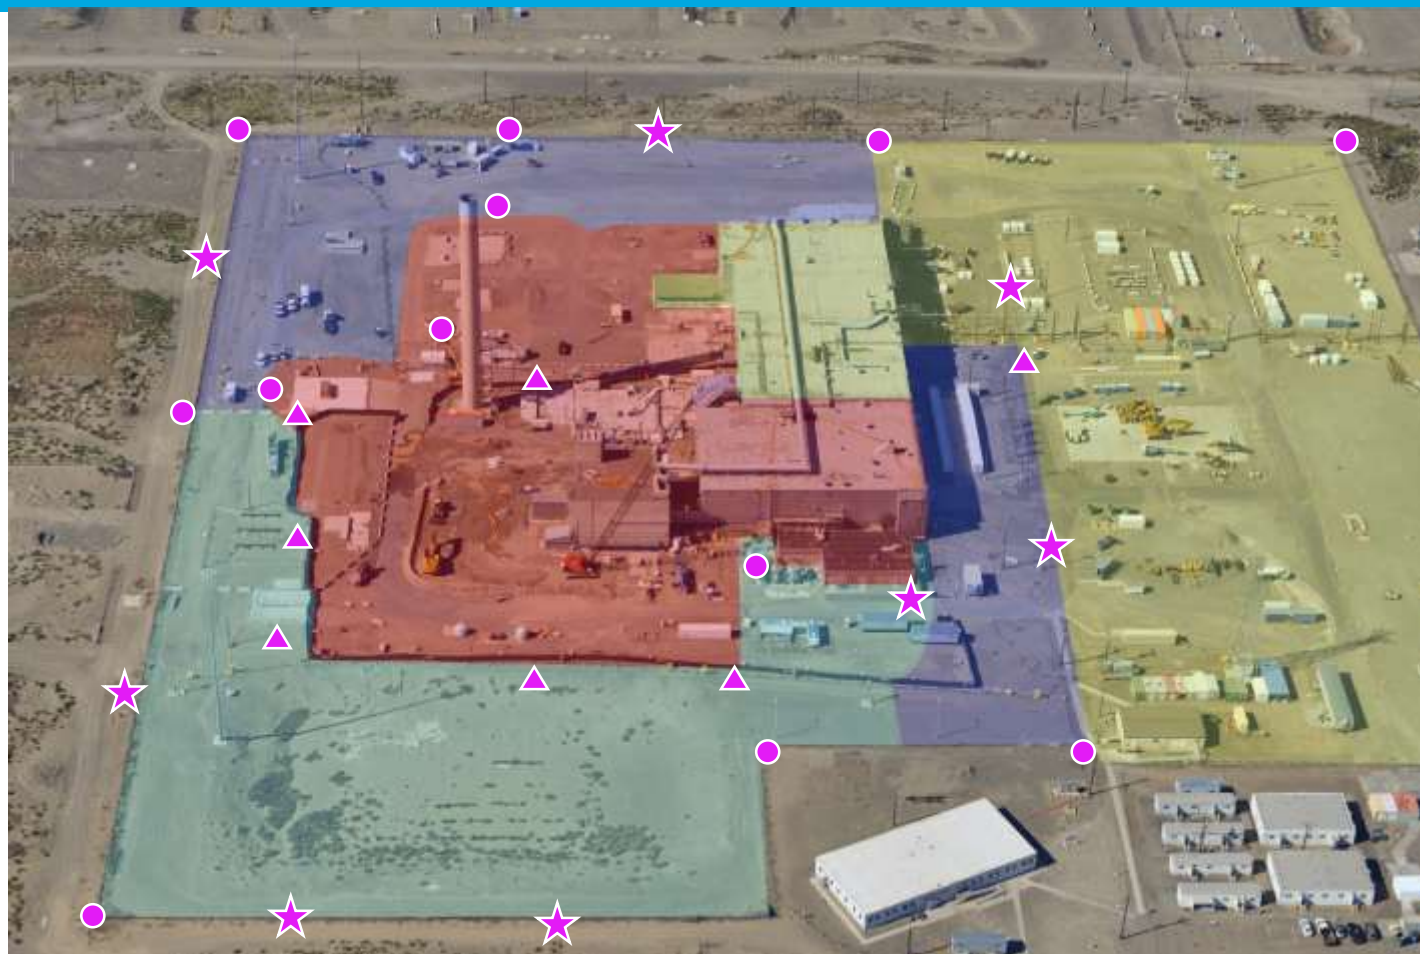
Site Map – Zones and Monitoring

Outer Fence/Laydown Area
Radiological Buffer Area

HCA/ARA
Contamination Area

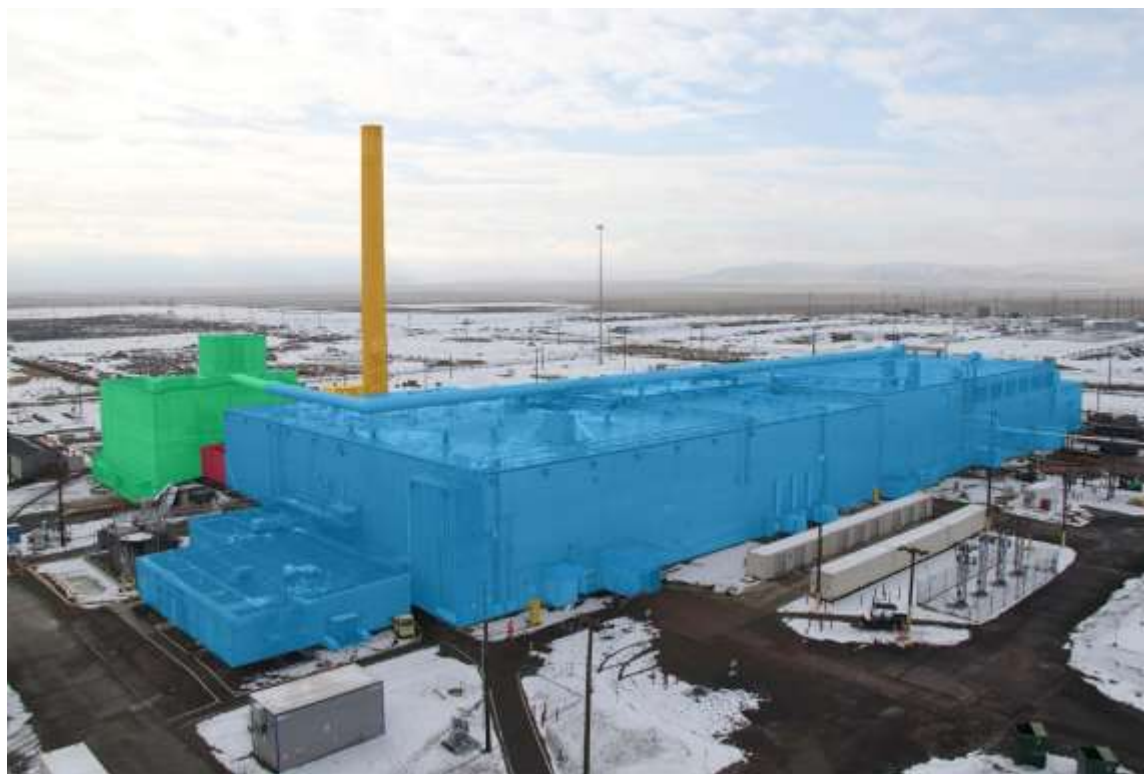
Demolition Sequence and Duration

1	Plutonium Reclamation Facility (236-Z)	Nov. 2016-July 2017	3	Plutonium Finishing Plant (234-5Z)	June 2017-Aug. 2017
2	Americium Recovery Facility (242-Z)	Complete!	4	Ventilation Stack and Fan House (291-Z)	June 2017-July 2017
